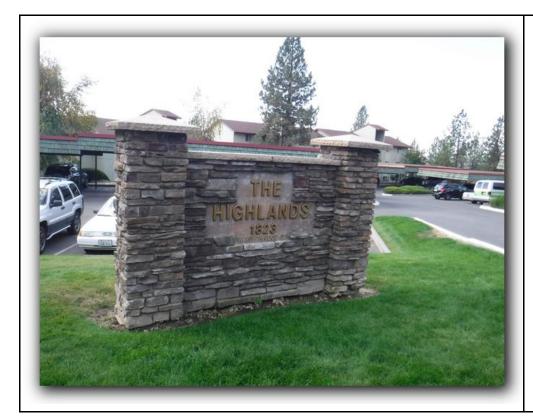
1

Entry monument

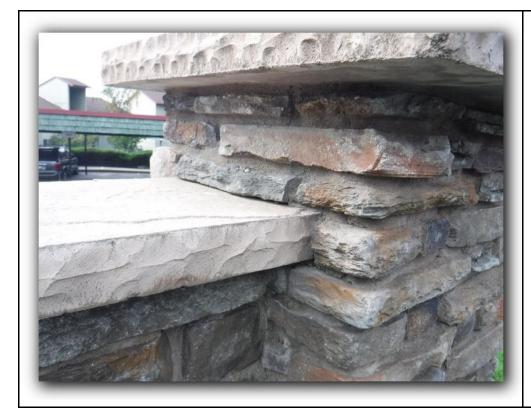
2

Possible gap/moisture entry on monument

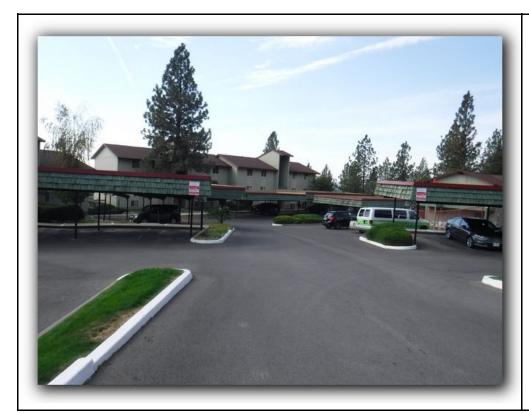
3

View from entry

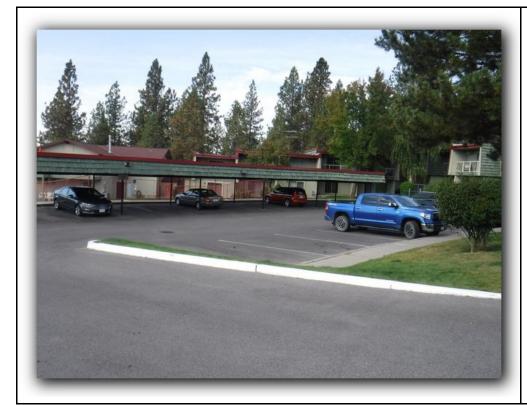
4

View from entry

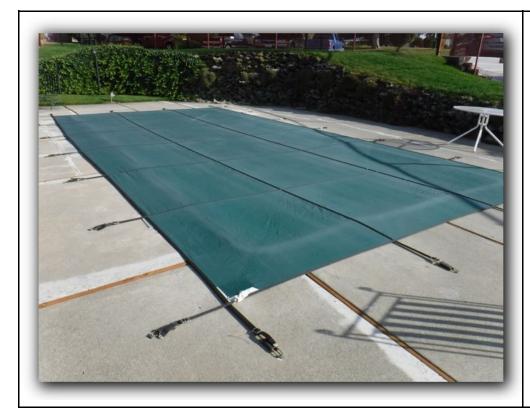
5

Swimming pool and deck

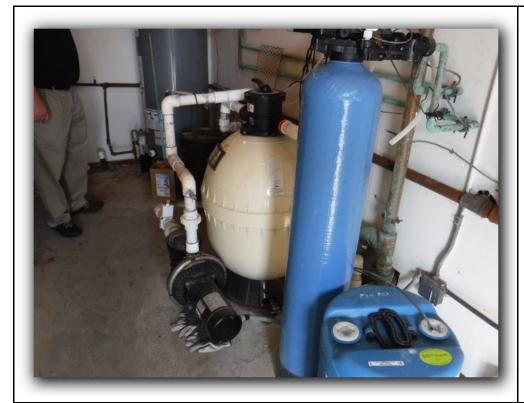
6

Pool equipment

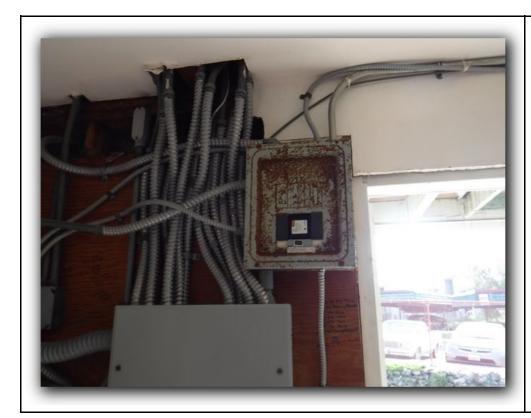
7

Corrosion on panel in pool room.

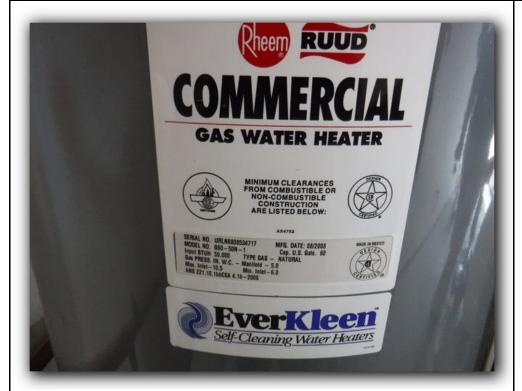
8

Clubhouse water heater

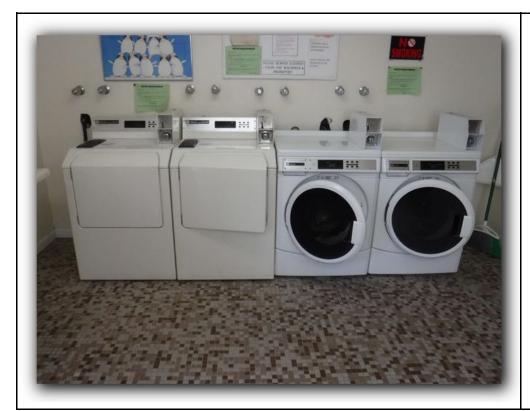
9

Clubhouse washing machines

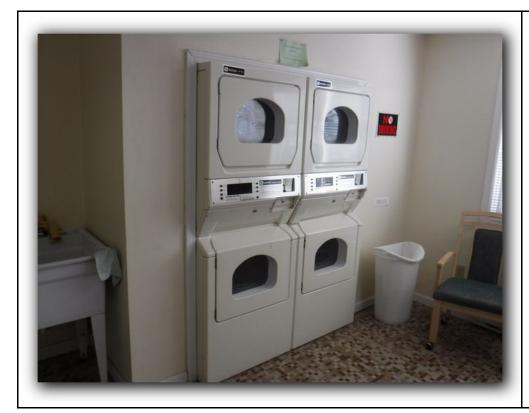
10

Clubhouse dryers

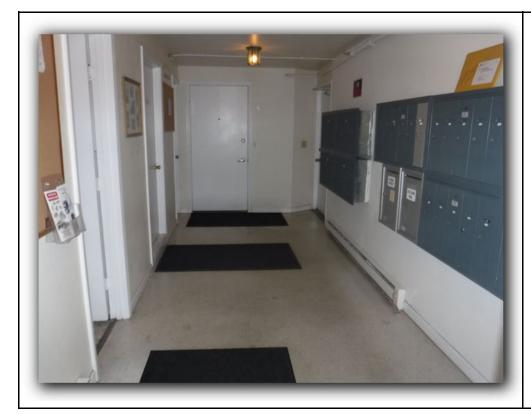
11

Clubhouse hallway and mailboxes.

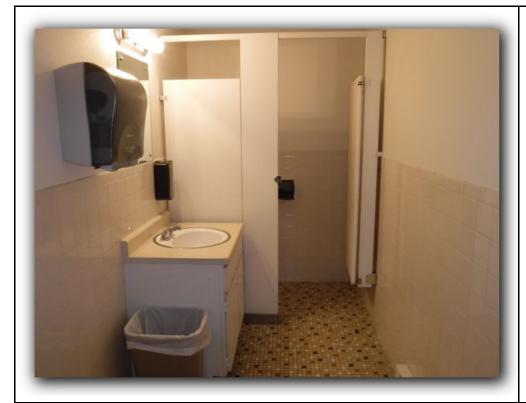
12

Clubhouse bathroom

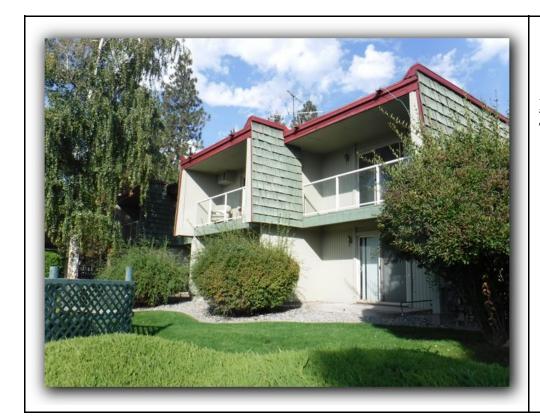
<u>Description</u>: Townhouse front

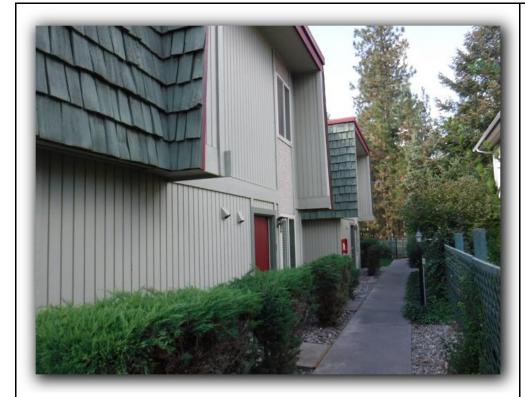
14

Townhouse rear

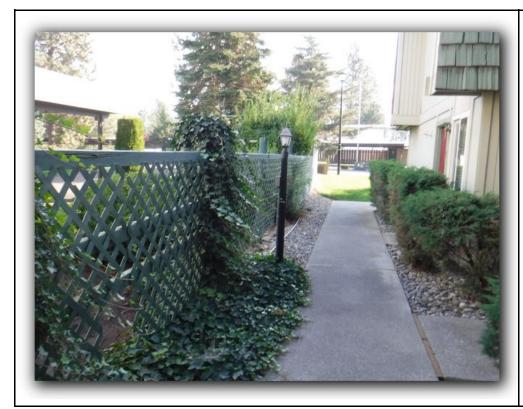
Wood/lattice fence and light pole

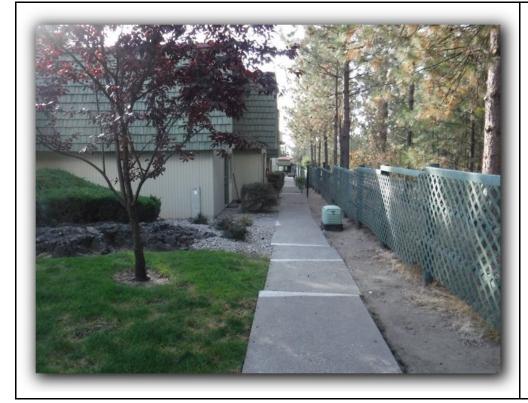
16

Townhouse, sidewalk, and fence

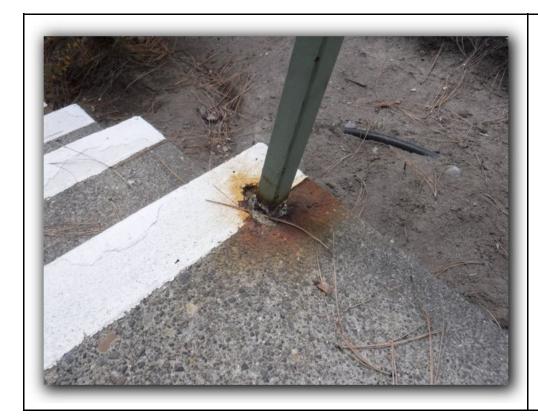
<u>Description</u>: Corrosion at handrail base

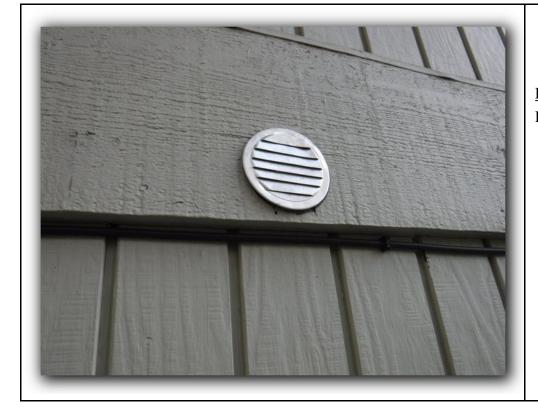
Photo Number 18

<u>Description</u>: Damaged ventilation screen

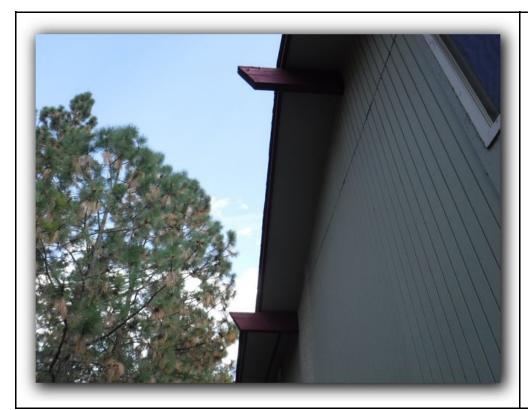
Clubhouse unprotected beam ends

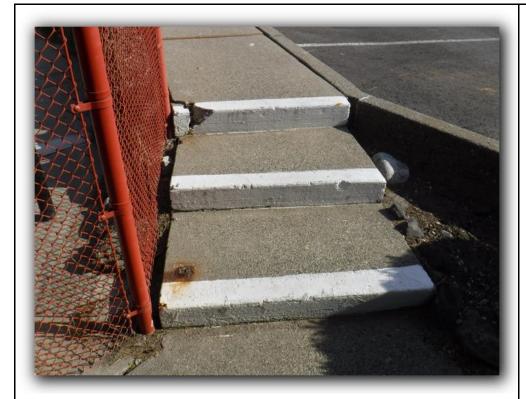
Photo Number **20**

Steps with missing handrail

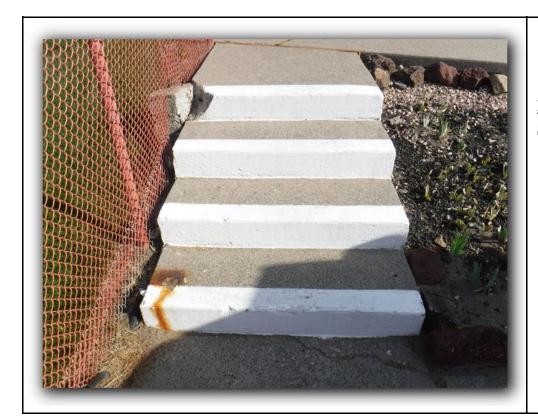
<u>Description</u>: Steps with missing handrail

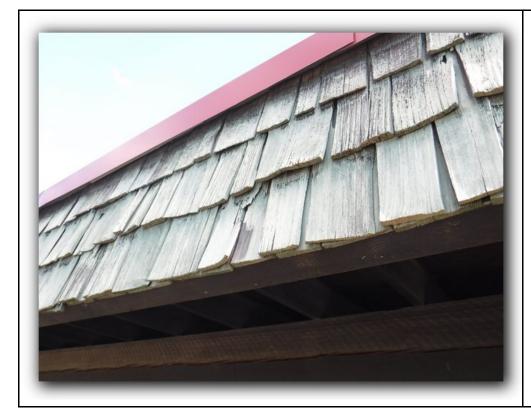
Photo Number **22**

Aging wood shingles on carport

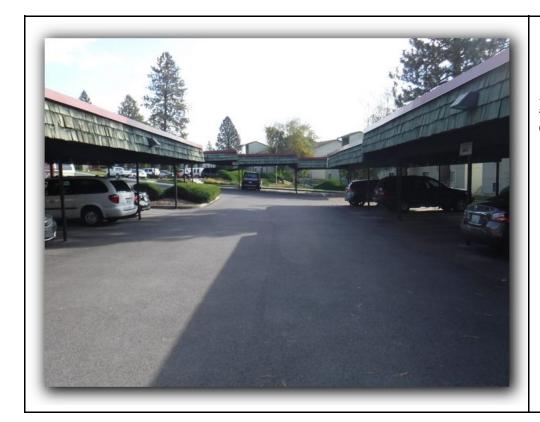
<u>Description</u>: Carport and driveway

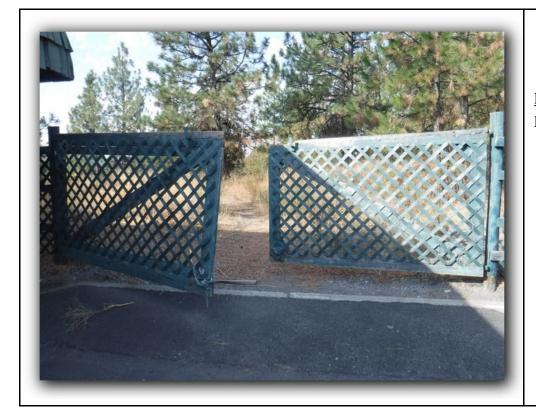
Photo Number **24**

<u>Description</u>: Emergency exit gate

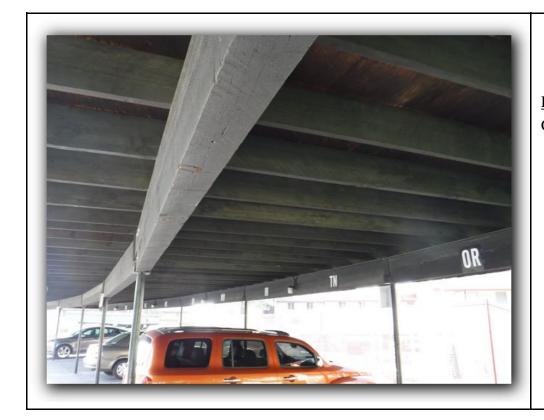
<u>Description</u>: Carport structure

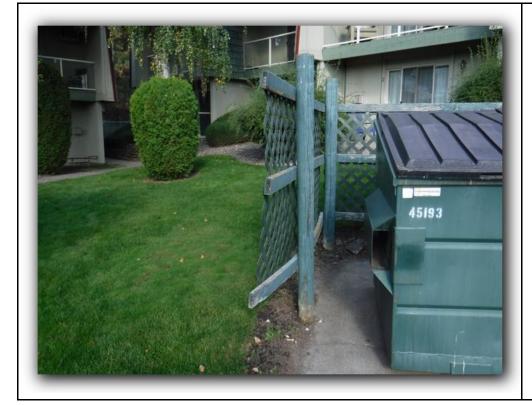
Photo Number **26**

Dumpster enclosure

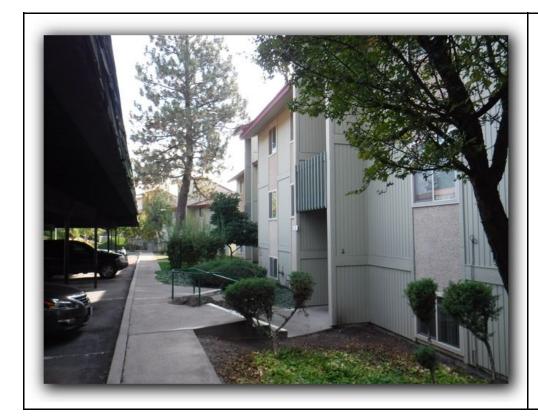
<u>Description</u>: West building and entry

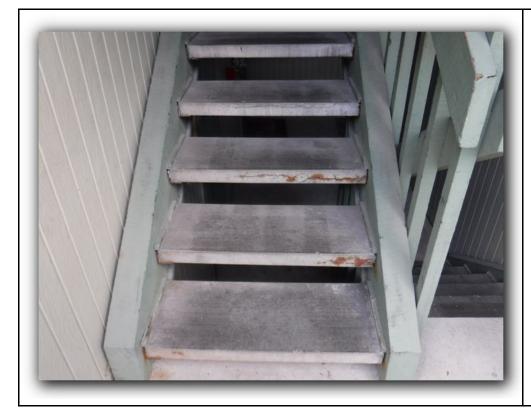
Photo Number **28**

<u>Description</u>: Deteriorating steps

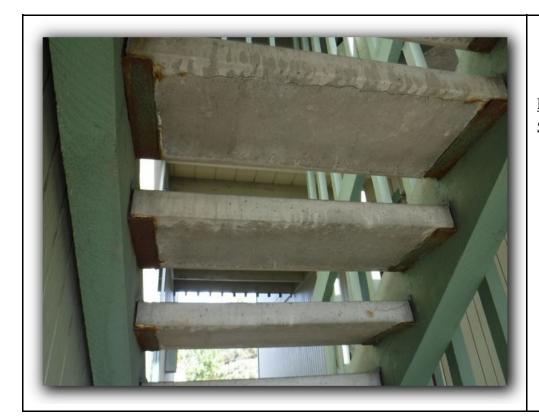
<u>Description</u>: Step bracket corrosion

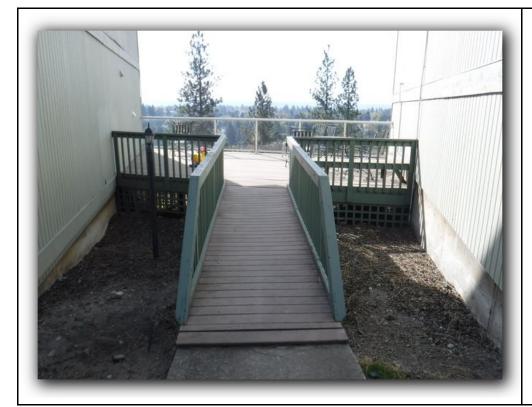
Photo Number **30**

<u>Description</u>: West sun deck

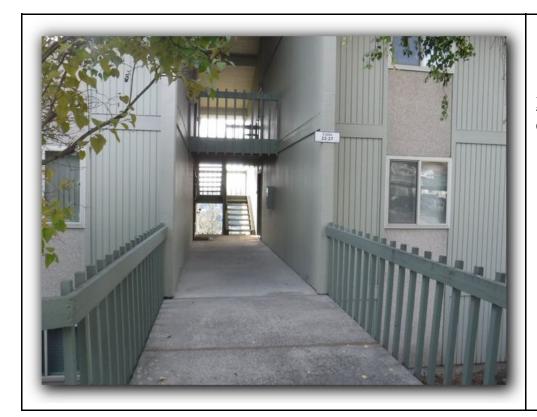
<u>Description</u>: Center building entry

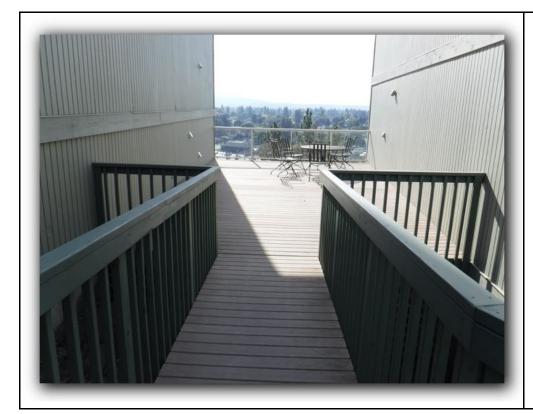
Photo Number 32

<u>Description</u>: East sun deck

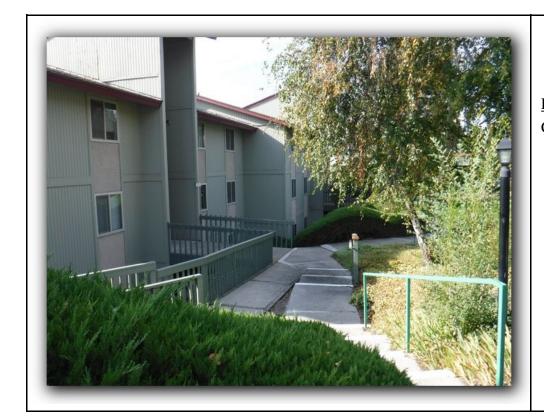
<u>Description</u>: Center building

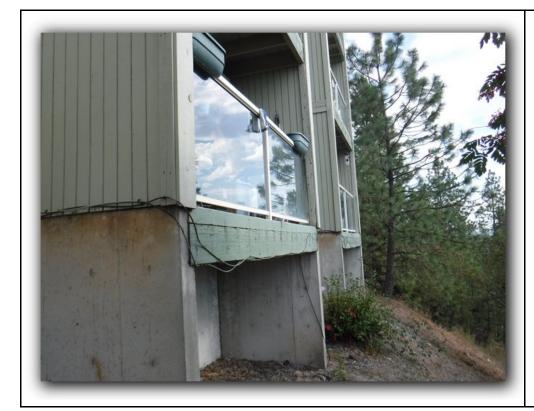
34

Rear of east building

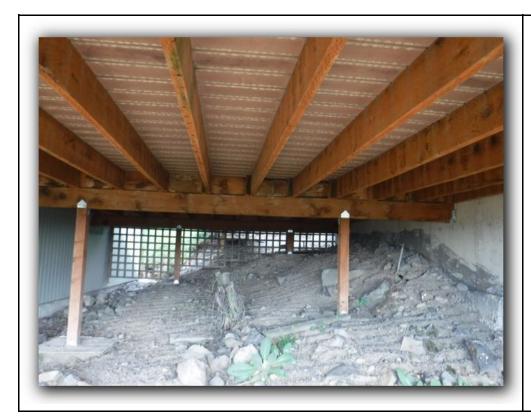
East sun deck structure

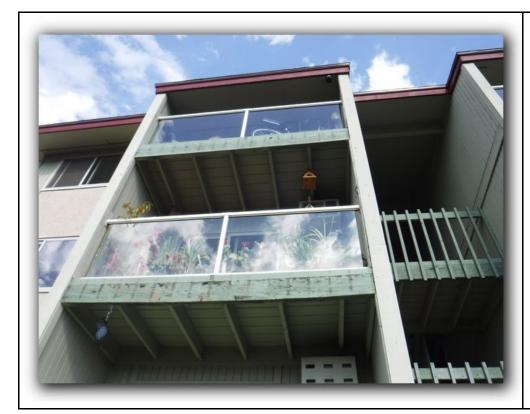
36

Rear of center building. Note weathering deck rim joists.

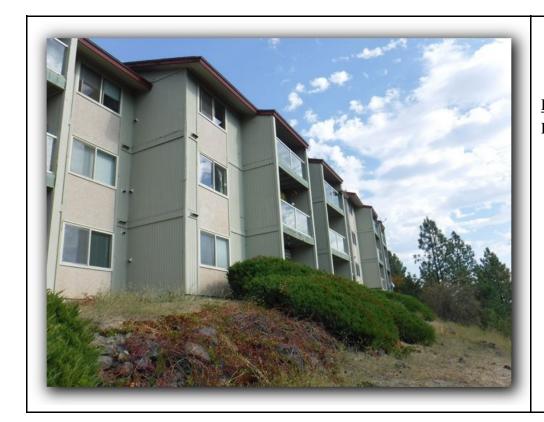
<u>Description</u>: Rear of buildings

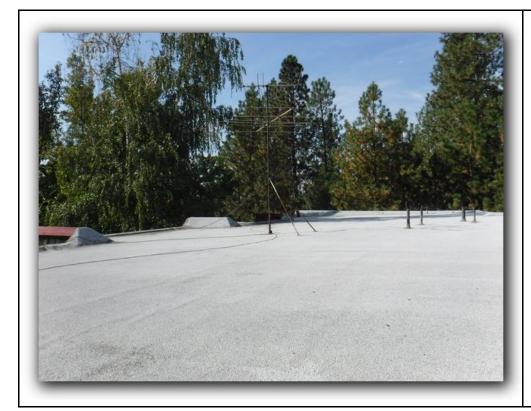
Photo Number **38**

<u>Description</u>: Townhouse roof

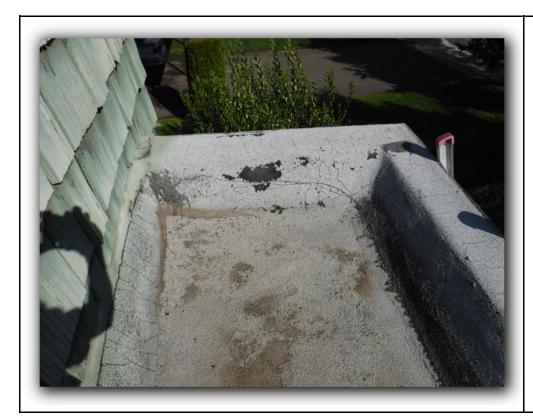
<u>Description</u>: Cracking at townhouse storage roof

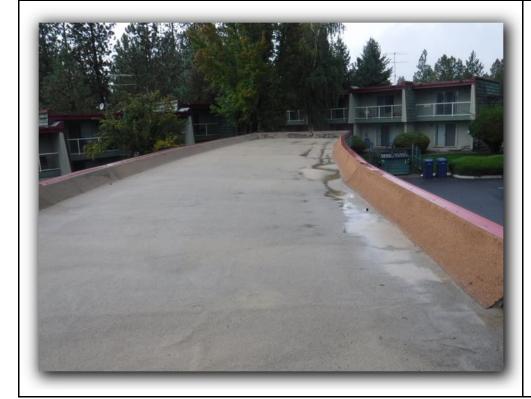
Photo Number **40**

<u>Description</u>: Carport roof-note newer parapet section at right

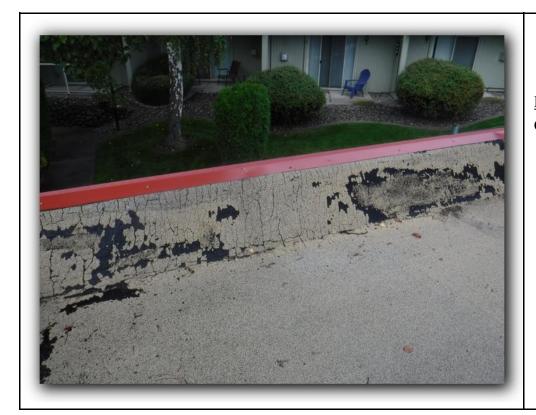
<u>Description</u>: Carport roof deterioration

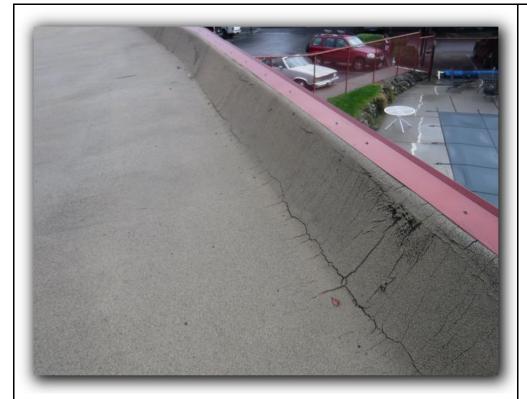
Photo Number **42**

<u>Description</u>: Carport roof cracking
