**Location**  
Overlook at Qualchan,  
Spokane, WA

**Photos Taken by:**  
Kenneth Pfaff, P.E.

**Inspection Date:**  
September 22, 2016

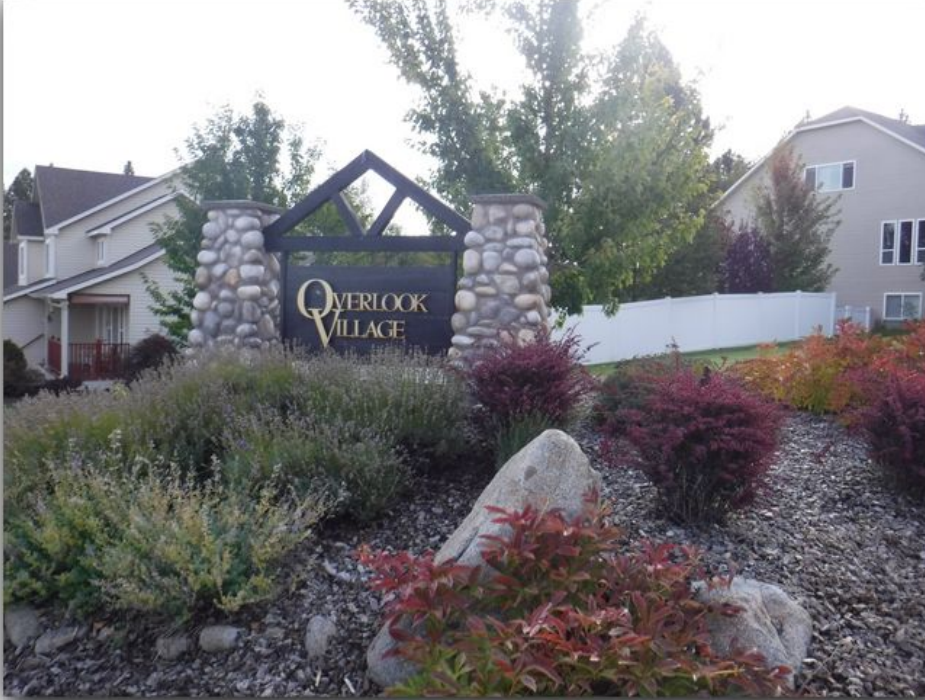
**1**

Description:  
Entry monument

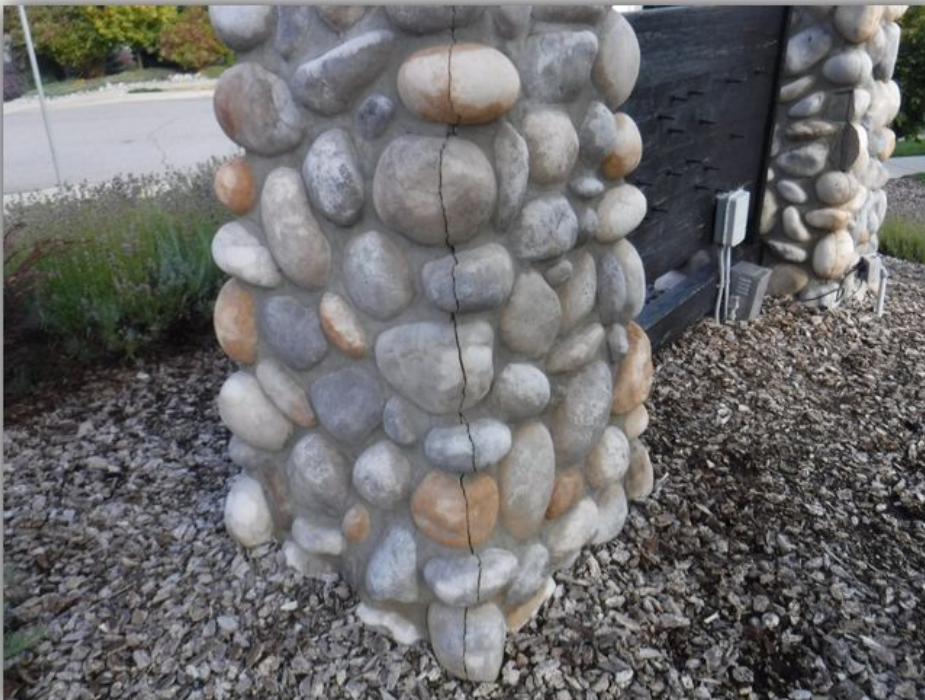
**2**

Description:  
Cracking at monument faux  
stone veneer

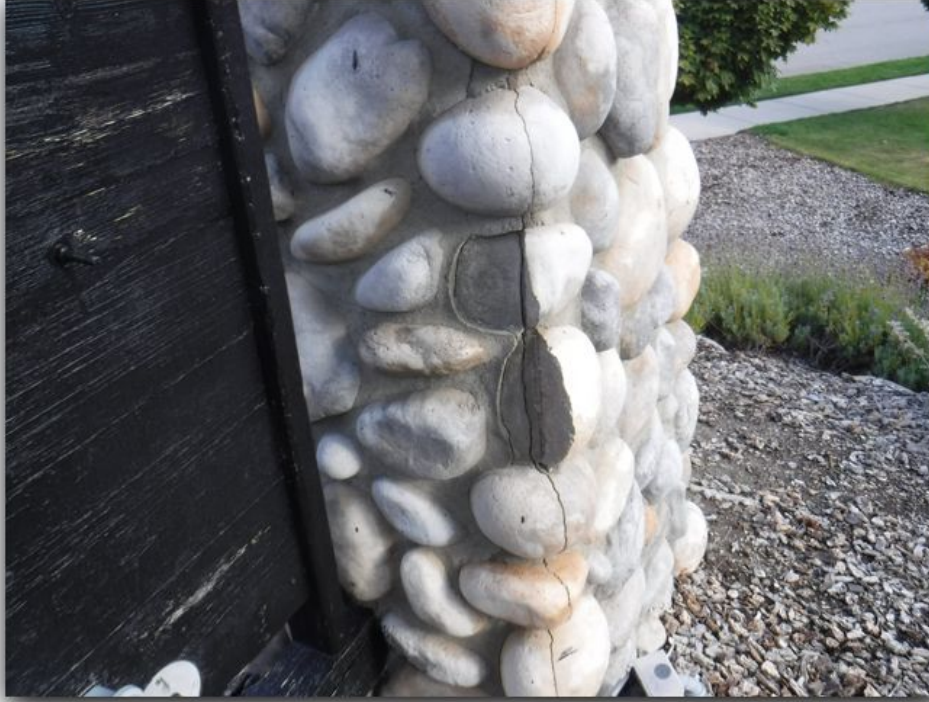
Photo Number  
**3**

Description:  
Cracking and missing faux  
stone veneer

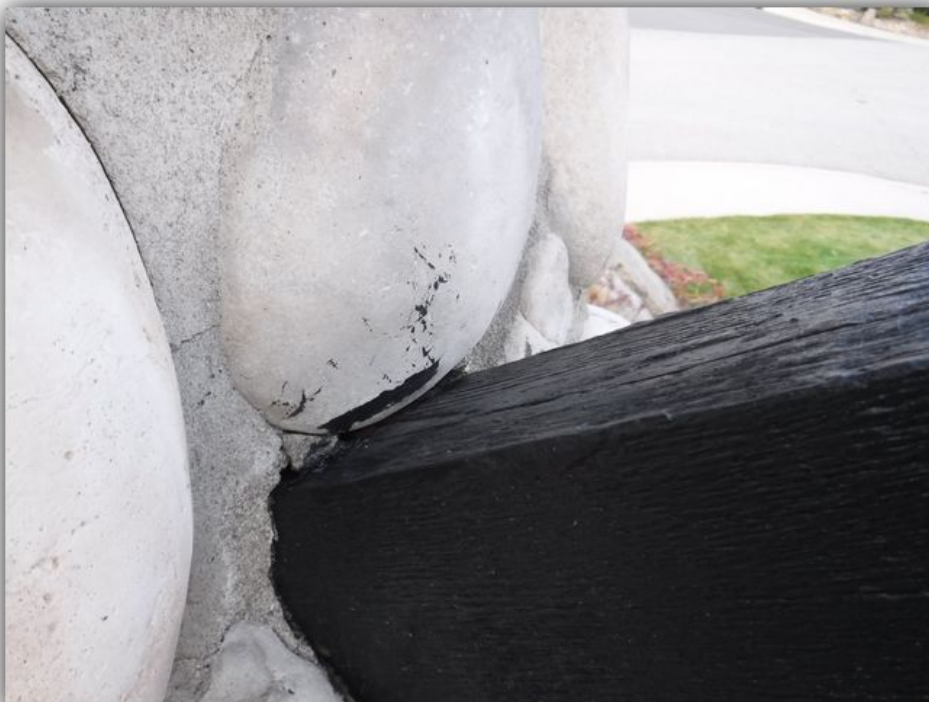
Photo Number  
**4**

Description:  
Possible moisture entry path  
at monument

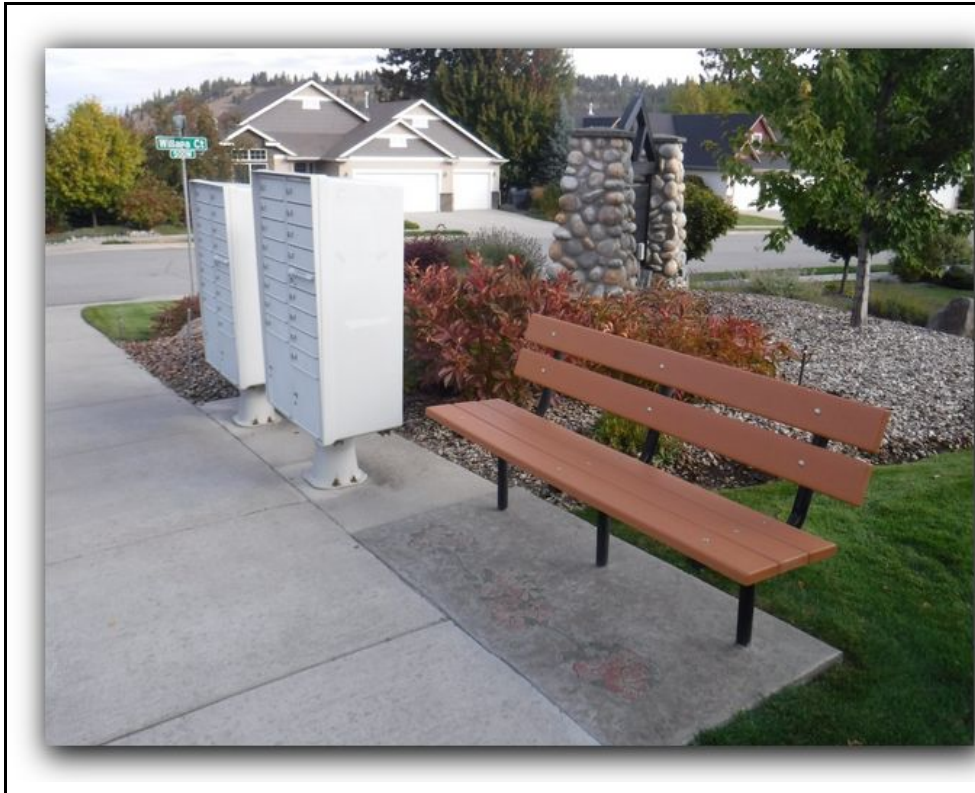
Photo Number  
**5**

Description:  
Mailboxes and park bench at monument area

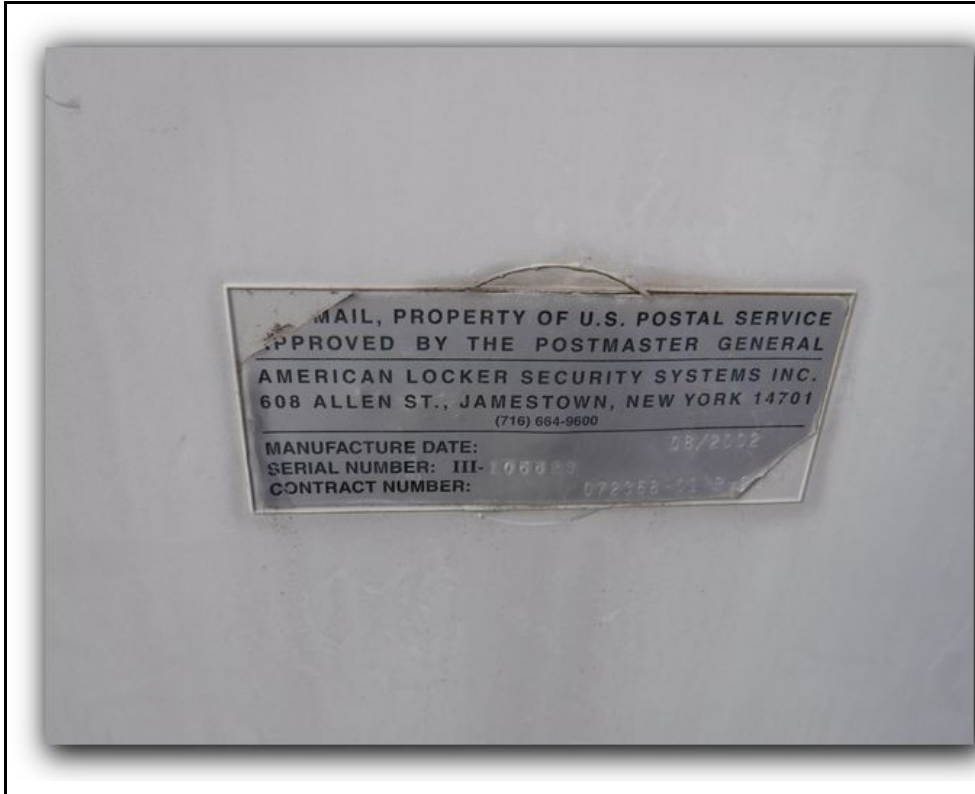
Photo Number  
**6**

Description:  
Mailbox information

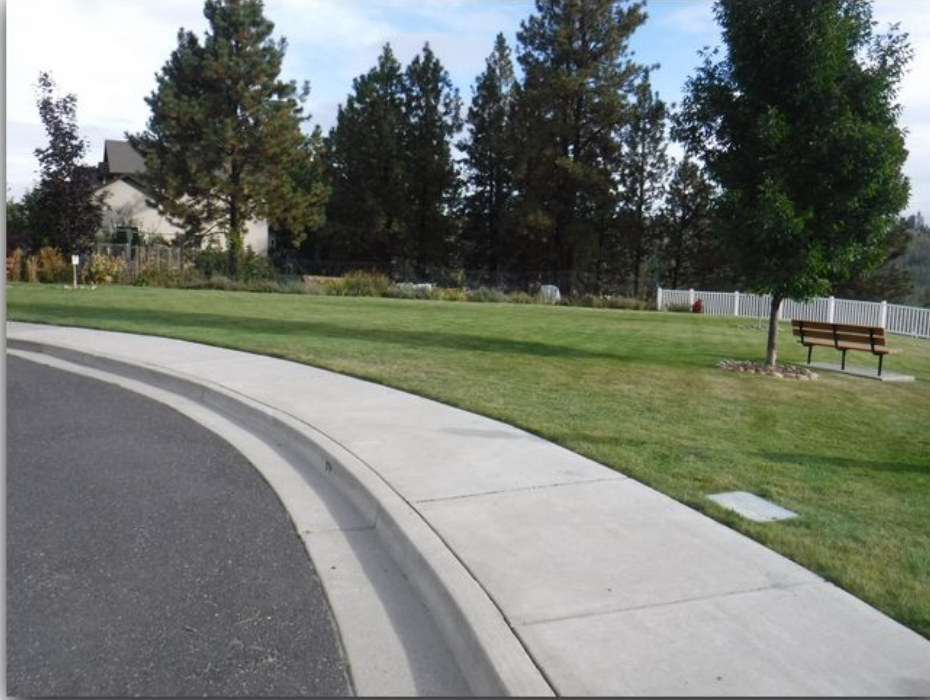
Photo Number  
**7**

Description:  
Bolan cul-de-sac park

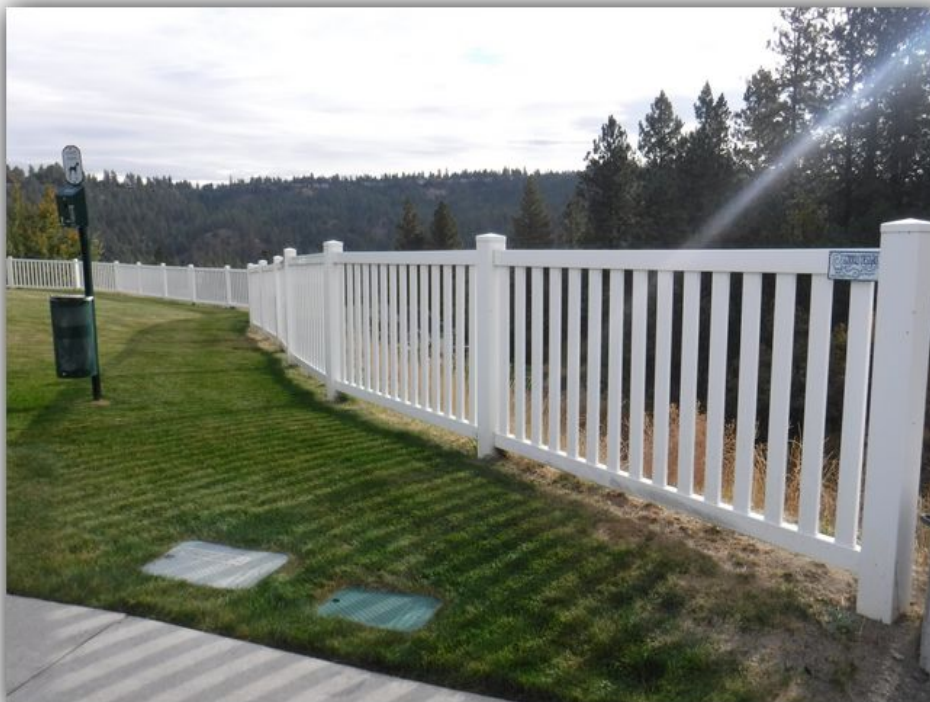
Photo Number  
**8**

Description:  
Fence at Bolan park

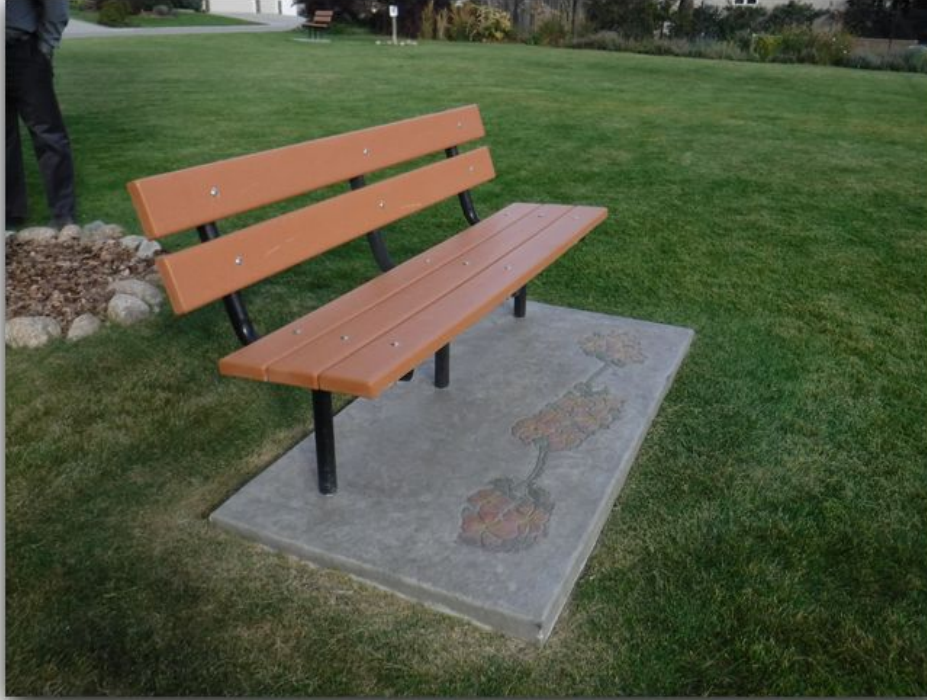
Photo Number  
**9**

Description:  
Park bench at Bolan park-1 of  
2

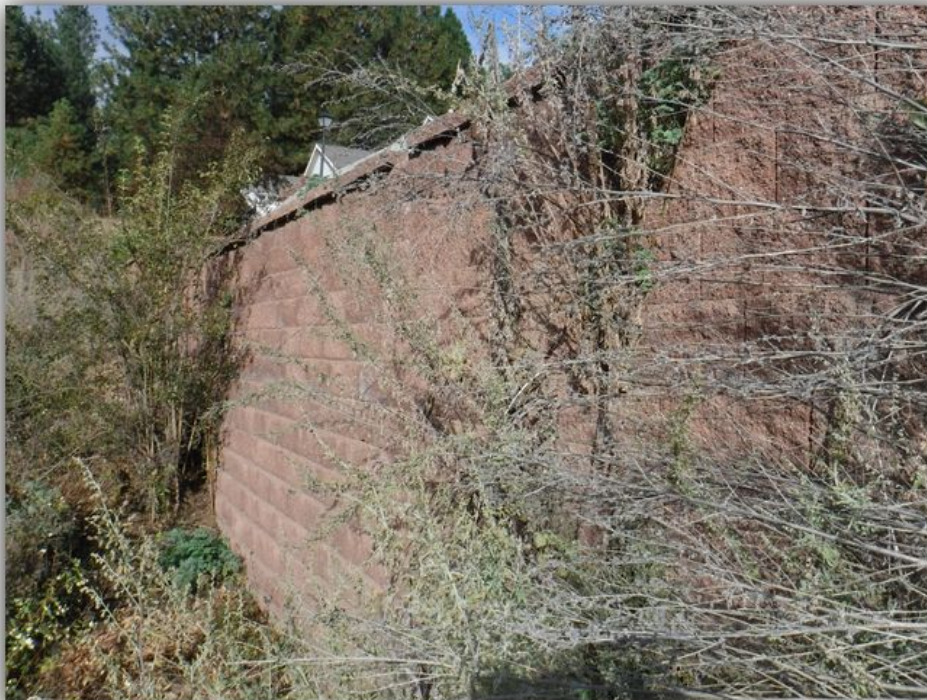
Photo Number  
**10**

Description:  
Weeds growing from retaining  
wall at Bolan cul-de-sac

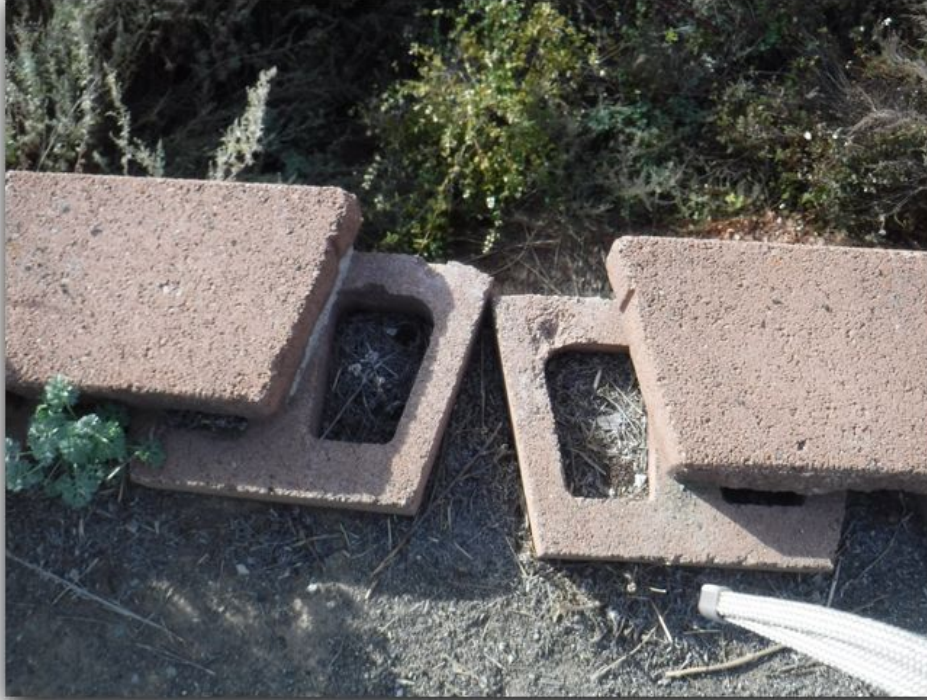
Photo Number  
**11**

Description:  
Missing cap at Bolan retaining wall

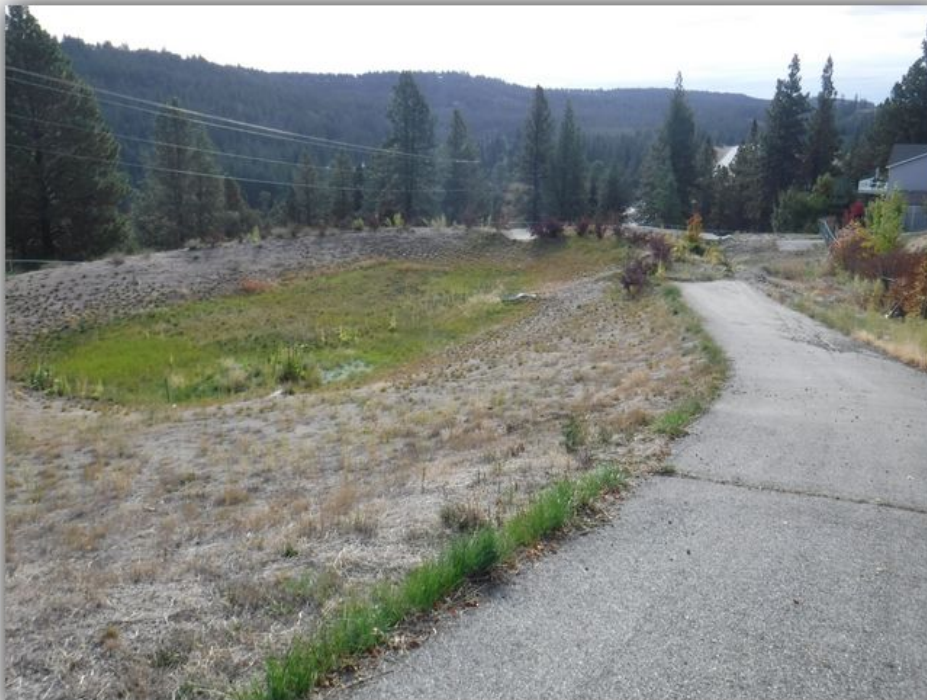
Photo Number  
**12**

Description:  
Menaul drainage ponds and path

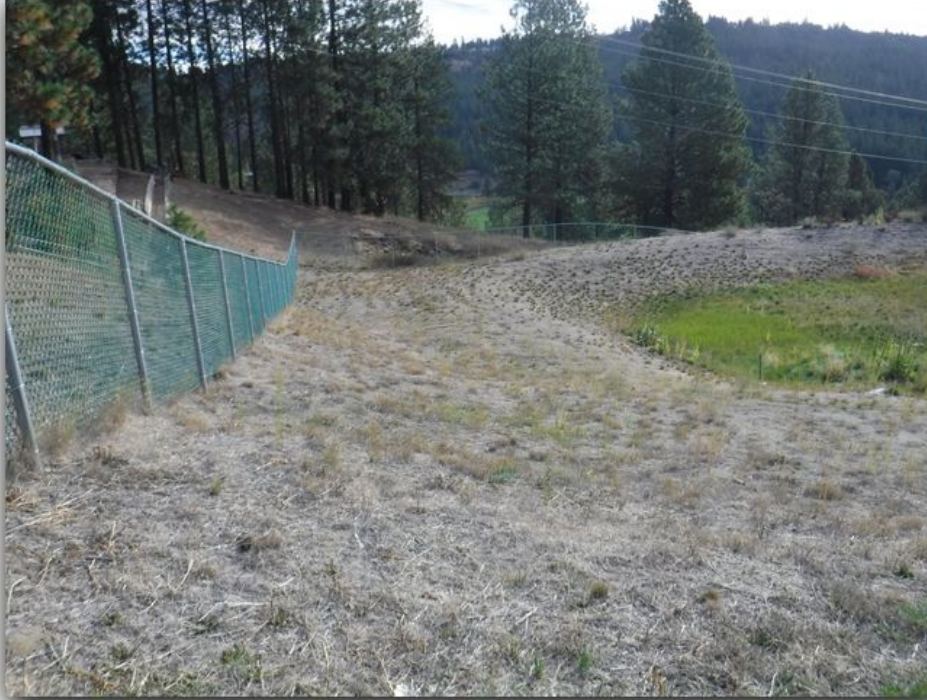
Photo Number  
**13**

Description:  
Chain link fence around  
Menaul drainage ponds

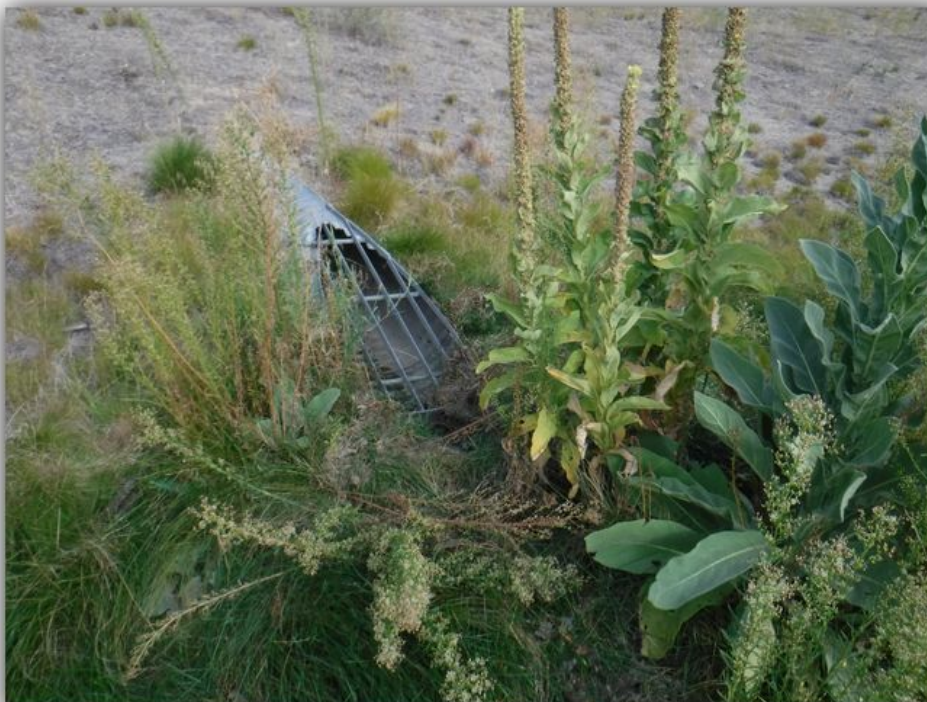
Photo Number  
**14**

Description:  
Inlet to upper drainage pond  
should be kept clear.

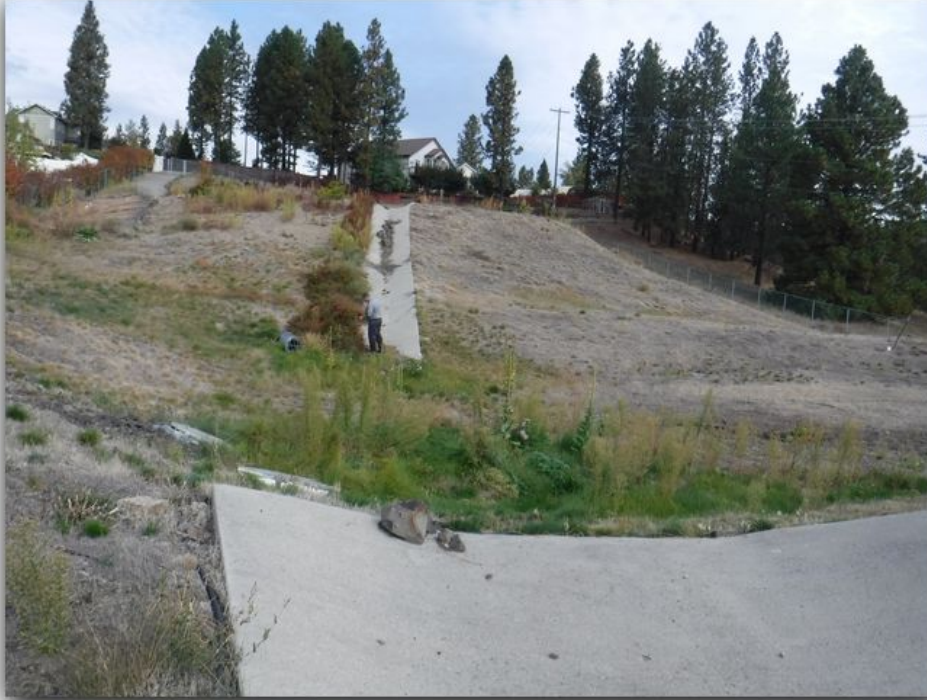
Photo Number  
**15**

Description:  
Concrete overflow channels  
from drainage ponds

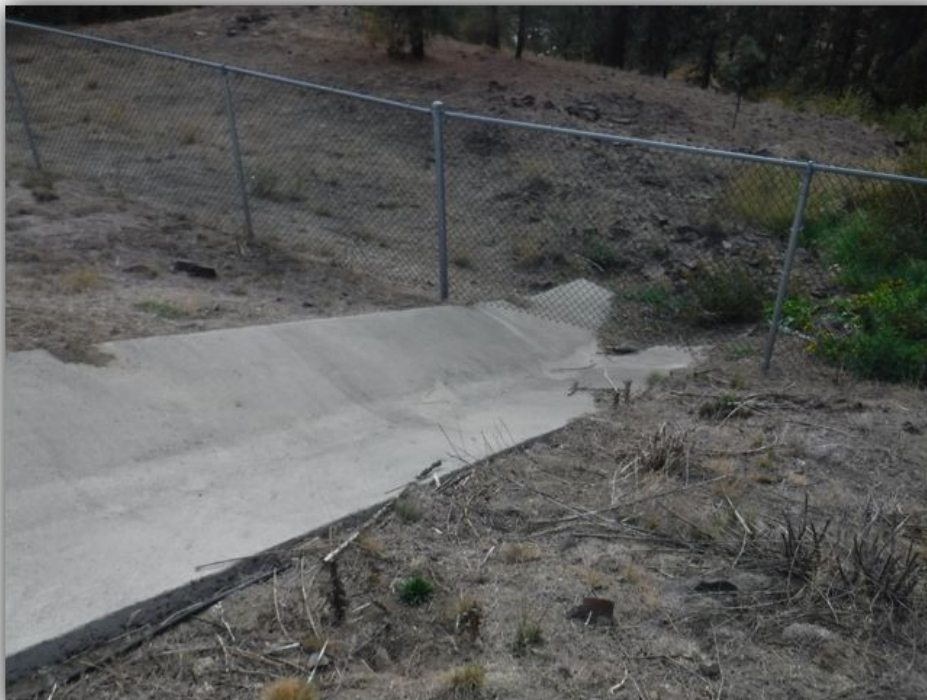
Photo Number  
**16**

Description:  
Overflow from lower drainage  
pond

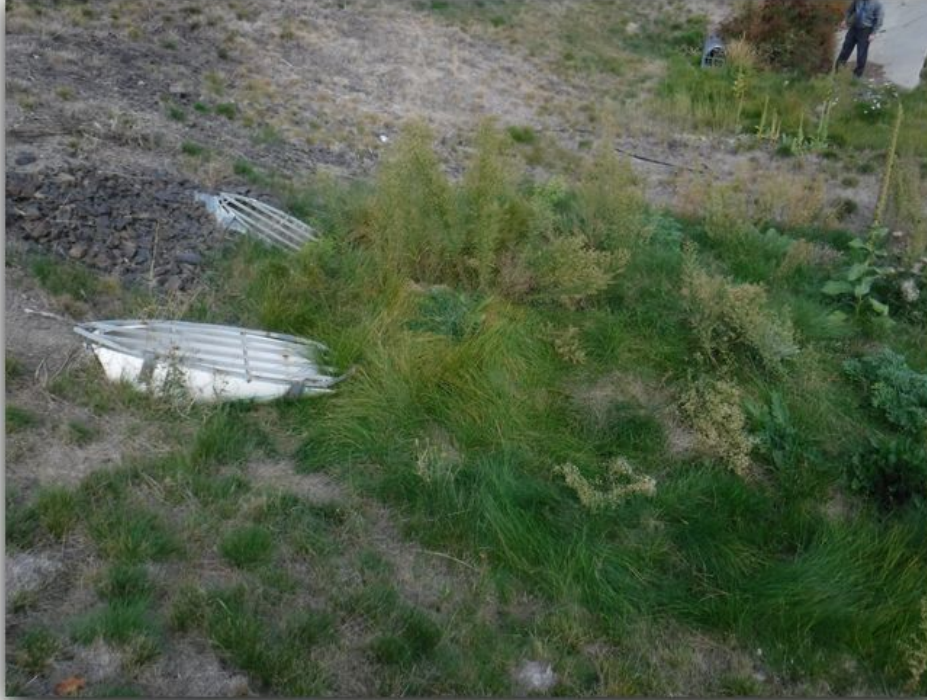
Photo Number  
**17**

Description:  
Inlets to lower drainage pond

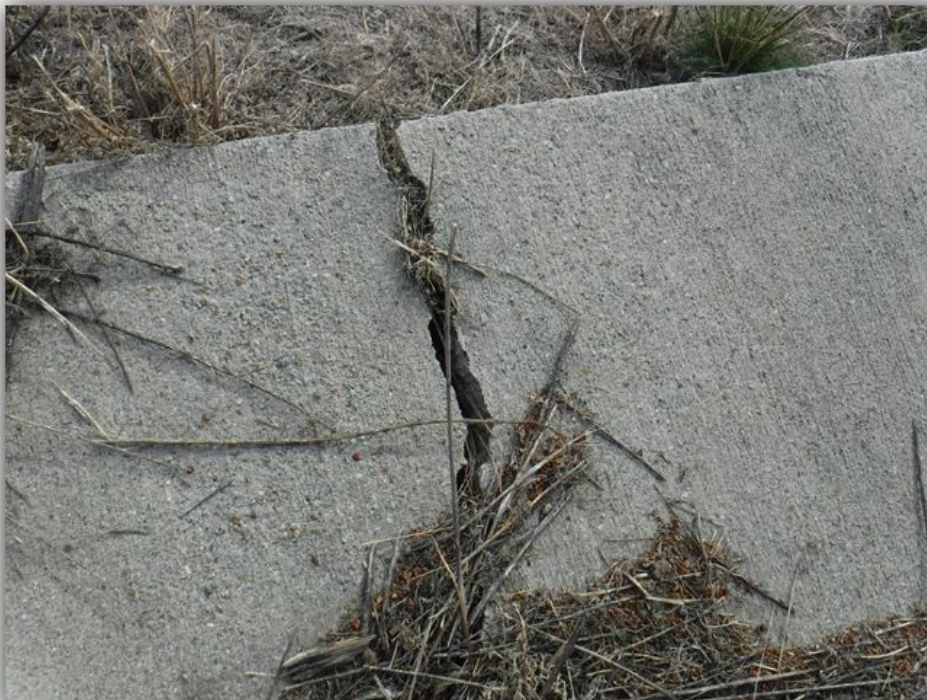
Photo Number  
**18**

Description:  
Crack in overflow channel

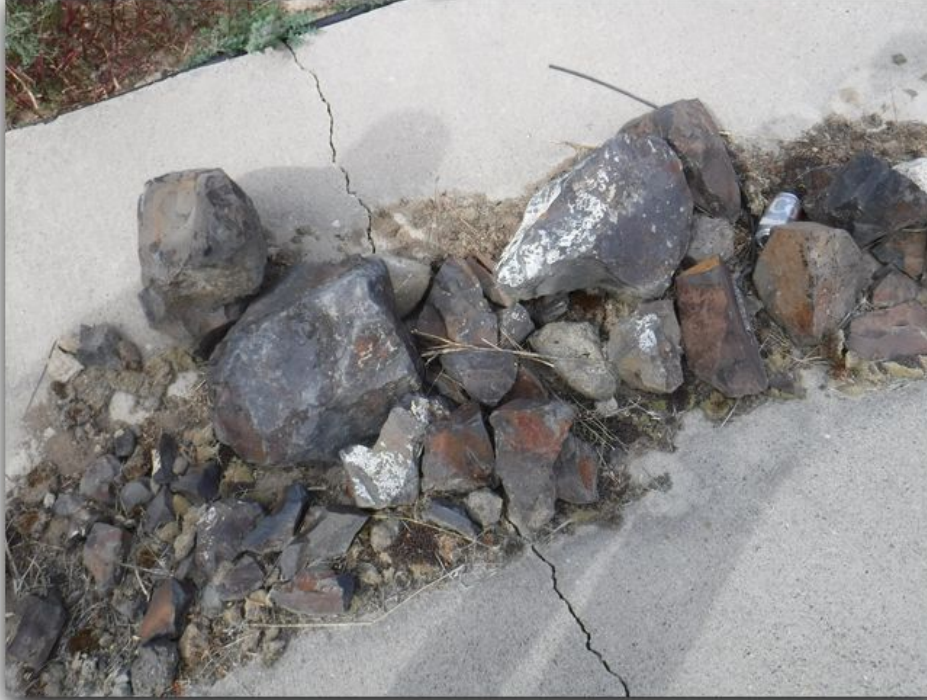
Photo Number  
**19**

Description:  
Smaller crack in overflow  
channel

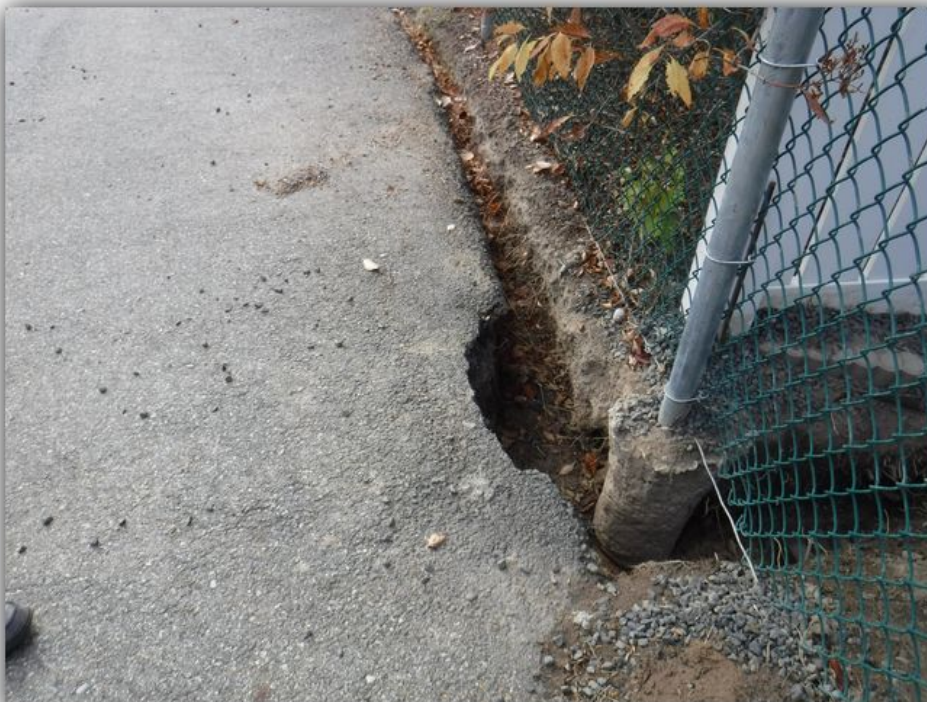
Photo Number  
**20**

Description:  
Homeowner excavation  
resulting in exposed footing  
and runoff onto upper Menaul  
path.

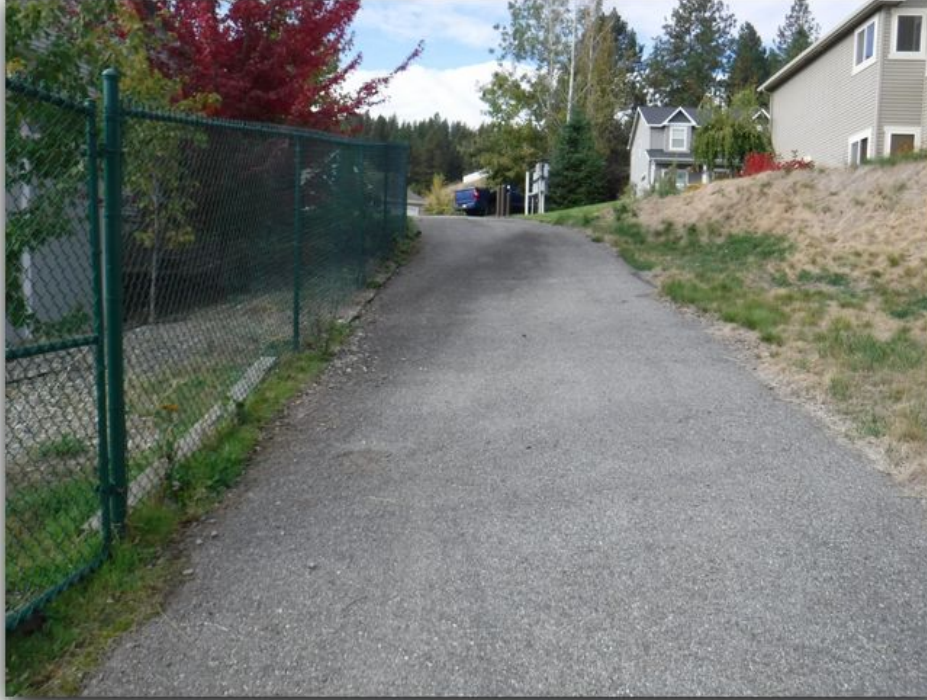
Photo Number  
**21**

Description:  
Lower Menaul path

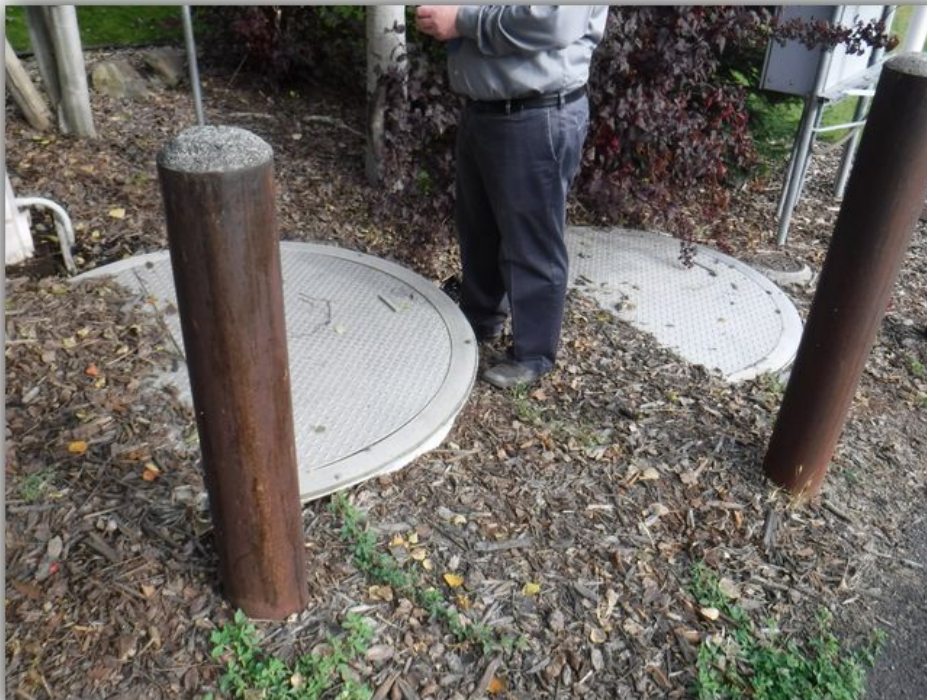
Photo Number  
**22**

Description:  
Sewer lift station at lower  
Menaul

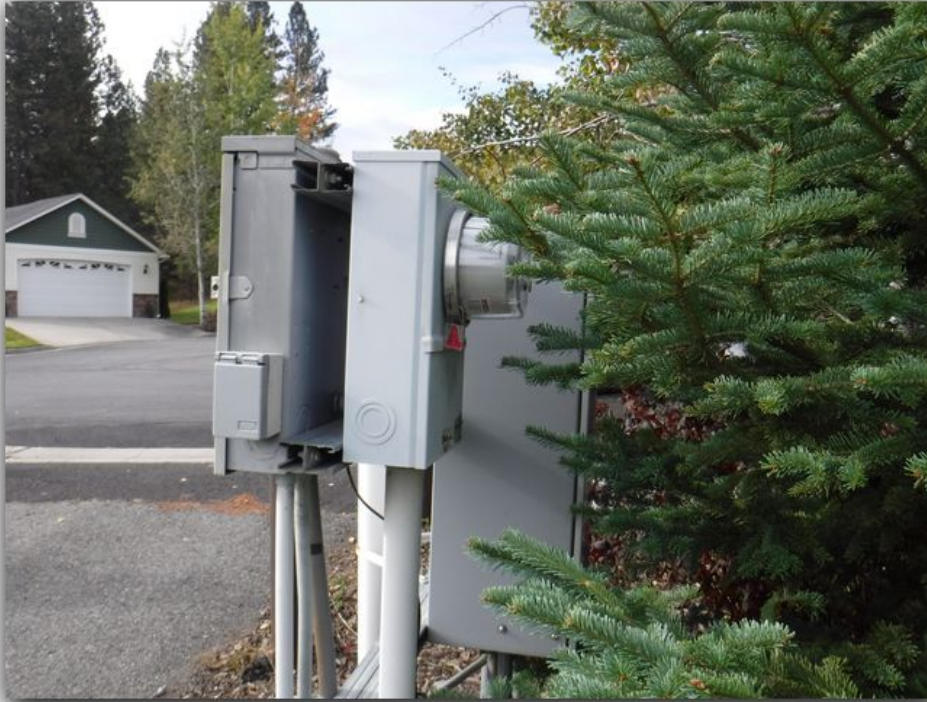
Photo Number  
**23**

Electrical meter and panels at  
lower Menaul lift station

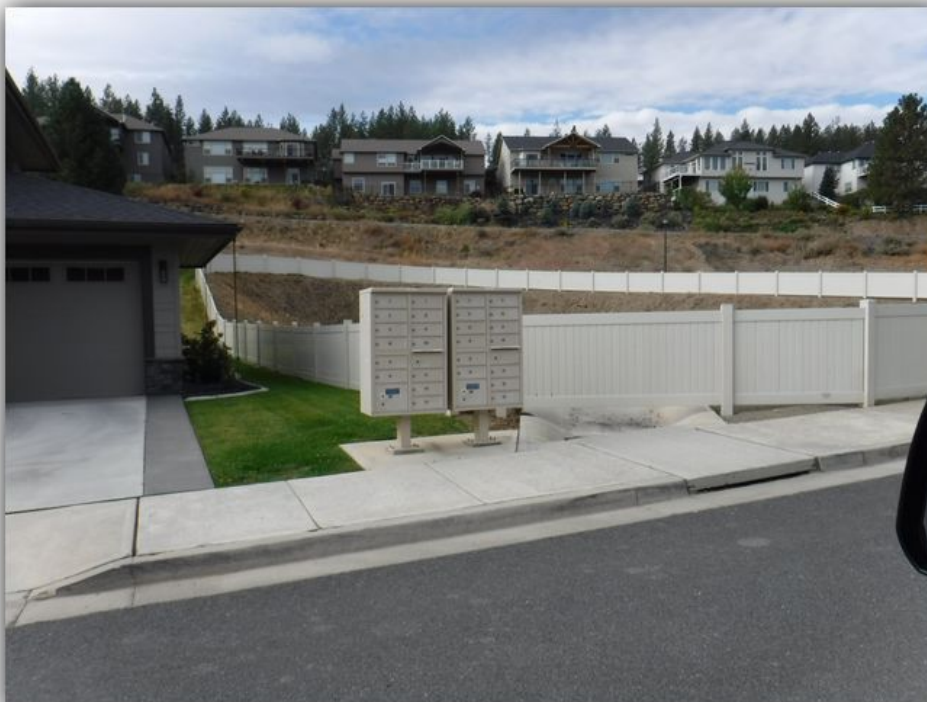
Photo Number  
**24**

Drainage swale, sidewalk,  
fence, and mailboxes at  
Jordan and Willapa.

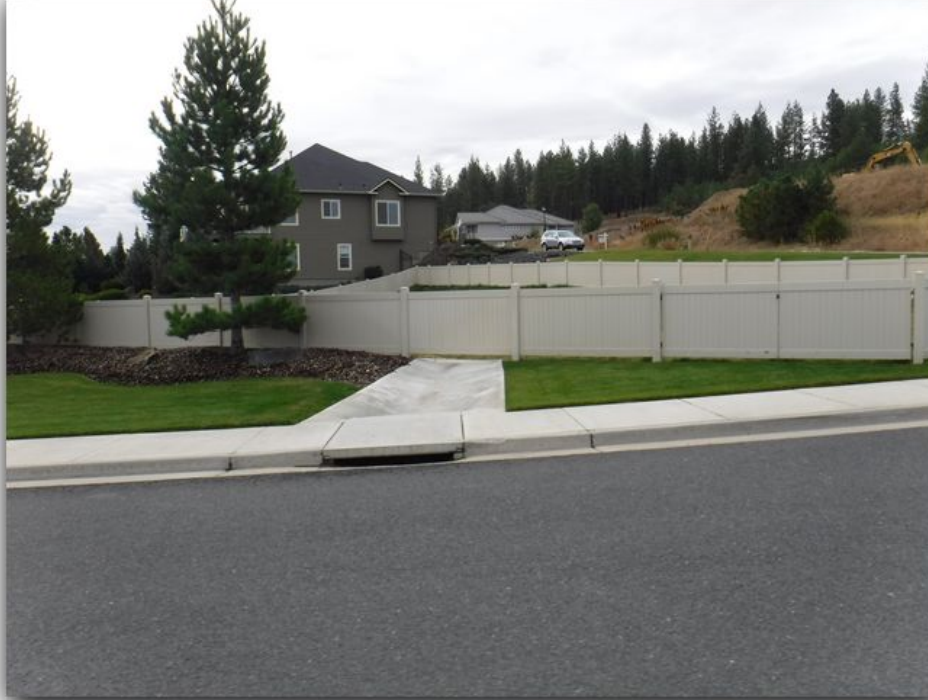
Photo Number  
**25**

Description:  
Drainage swale, fence,  
sidewalk, and overflow at  
Willapa and Lincoln.

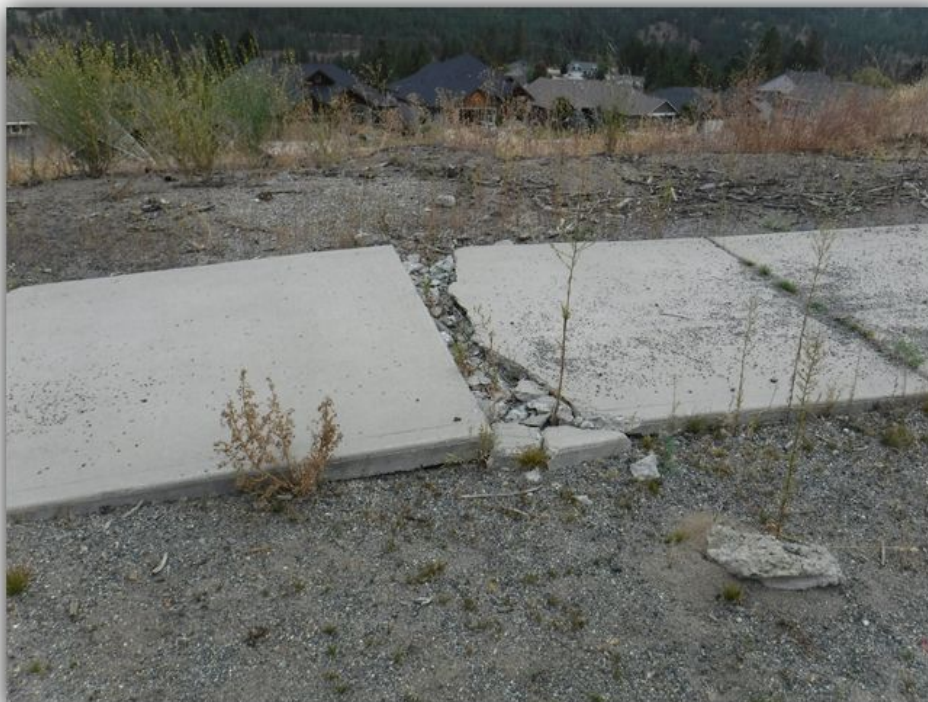
Photo Number  
**26**

Description:  
1 of 2 areas of damaged  
sidewalk on Lincoln owned  
by others

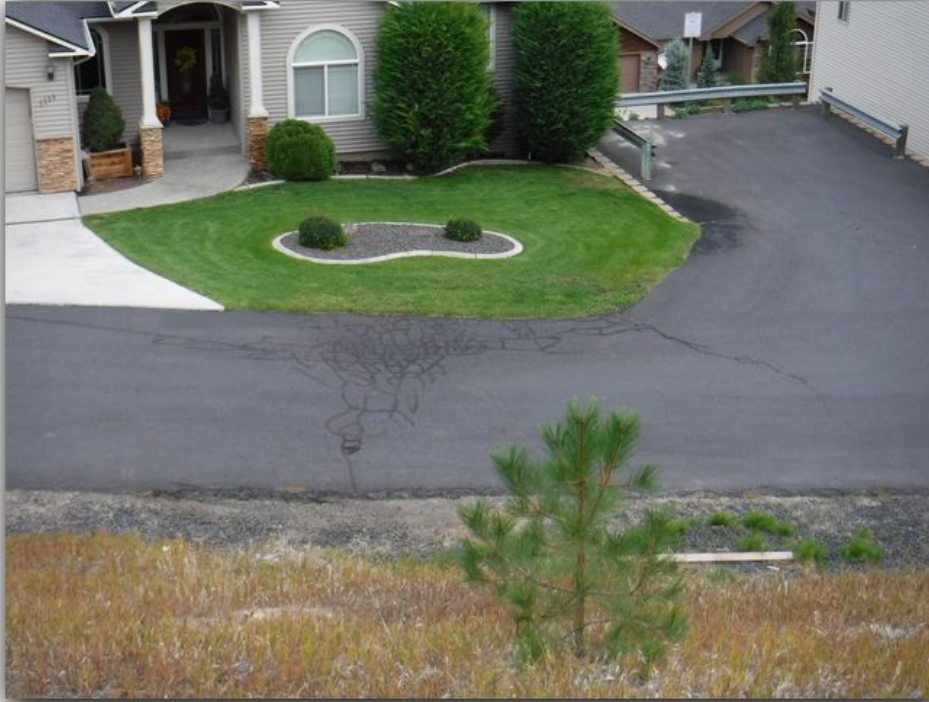
Photo Number  
**27**

Description:  
Broken up asphalt on Upper  
West Bolan.

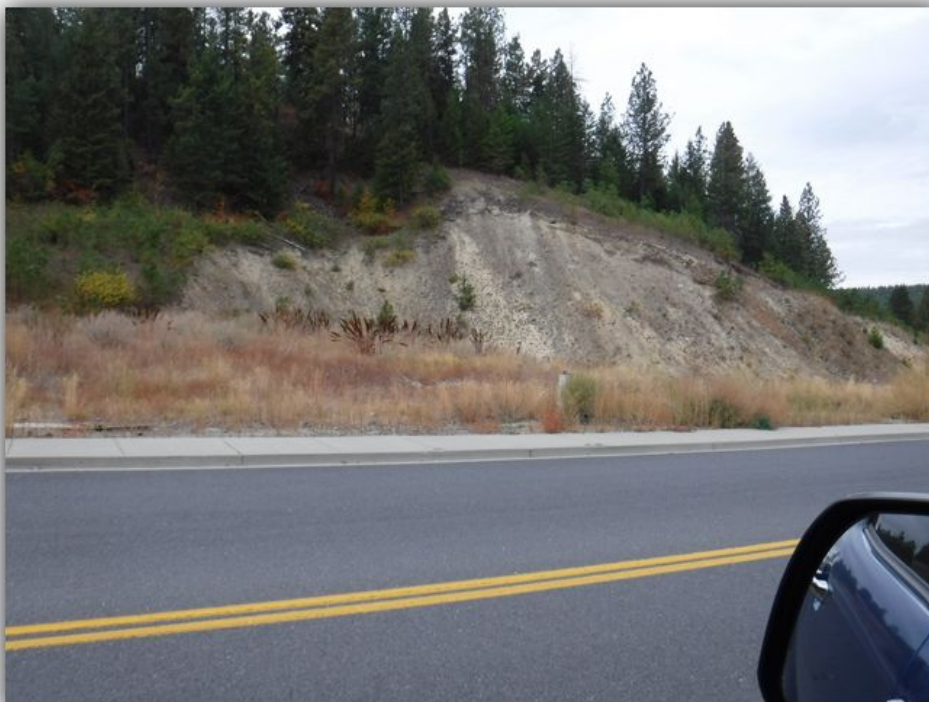
Photo Number  
**28**

Description:  
Excavated hillside may be  
liability if stabilization is  
needed. Need to determine  
responsibility.

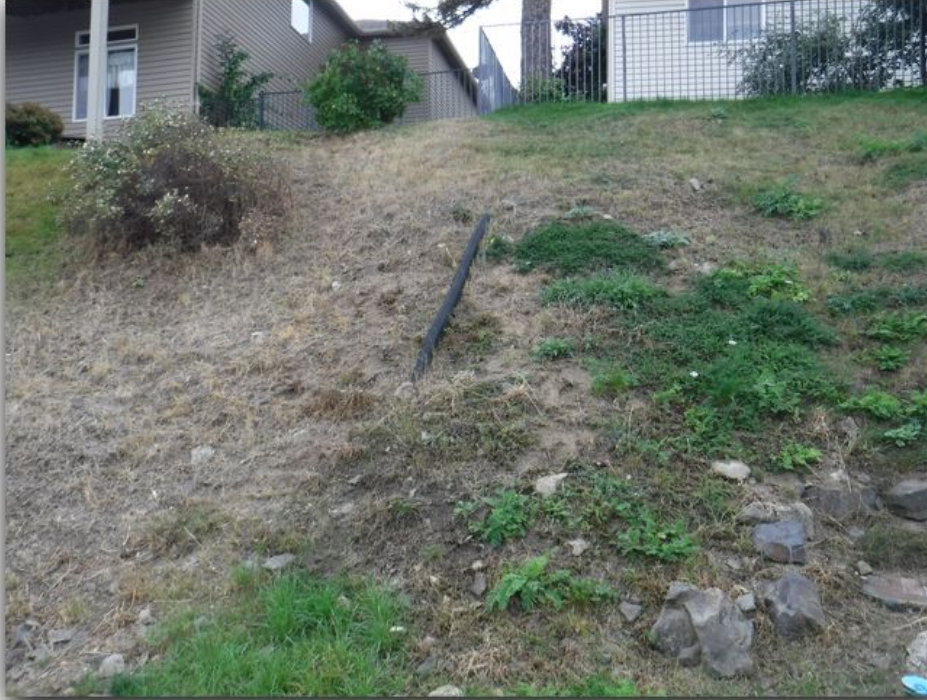
Photo Number  
**29**

Description:  
Exposed drainage pipe along  
Willapa.

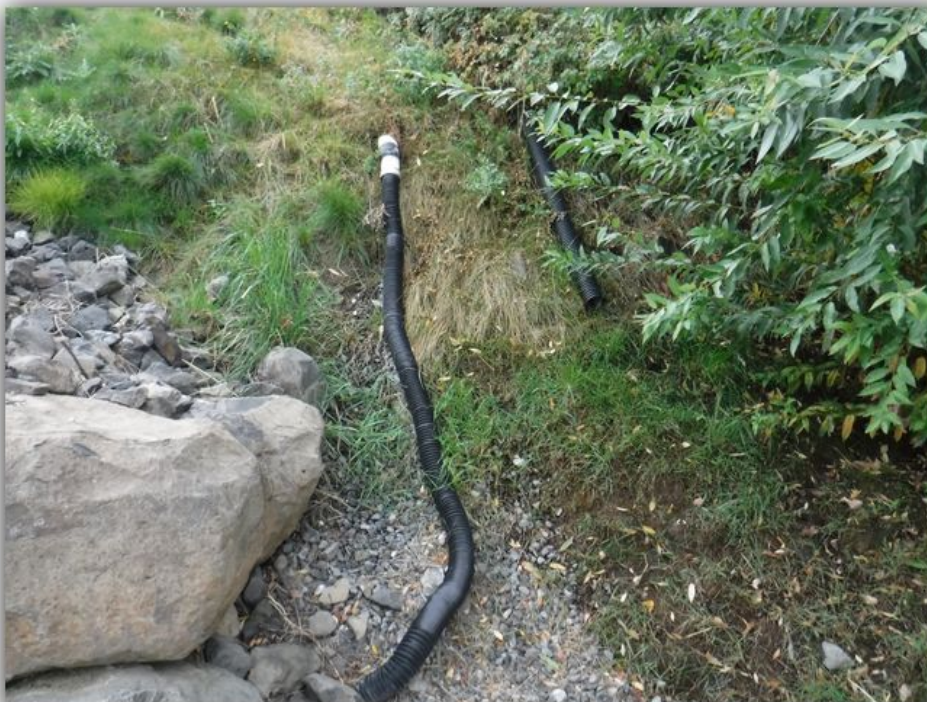
Photo Number  
**30**

Description:  
Exposed drainage pipes along  
Willapa.

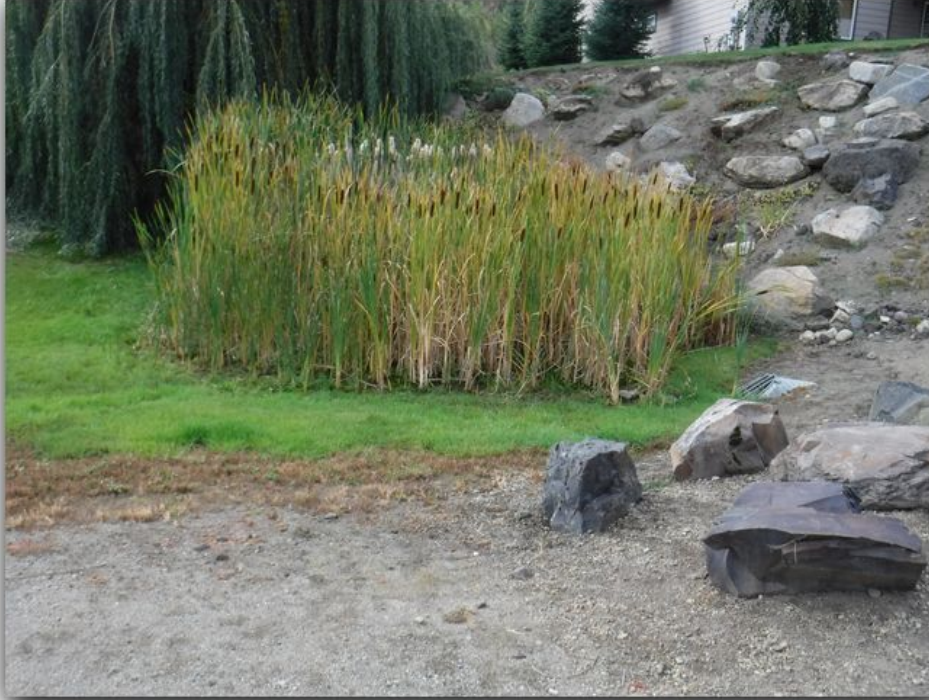
Photo Number  
**31**

Description:  
Swale at Bolan and Upper  
West Bolan.

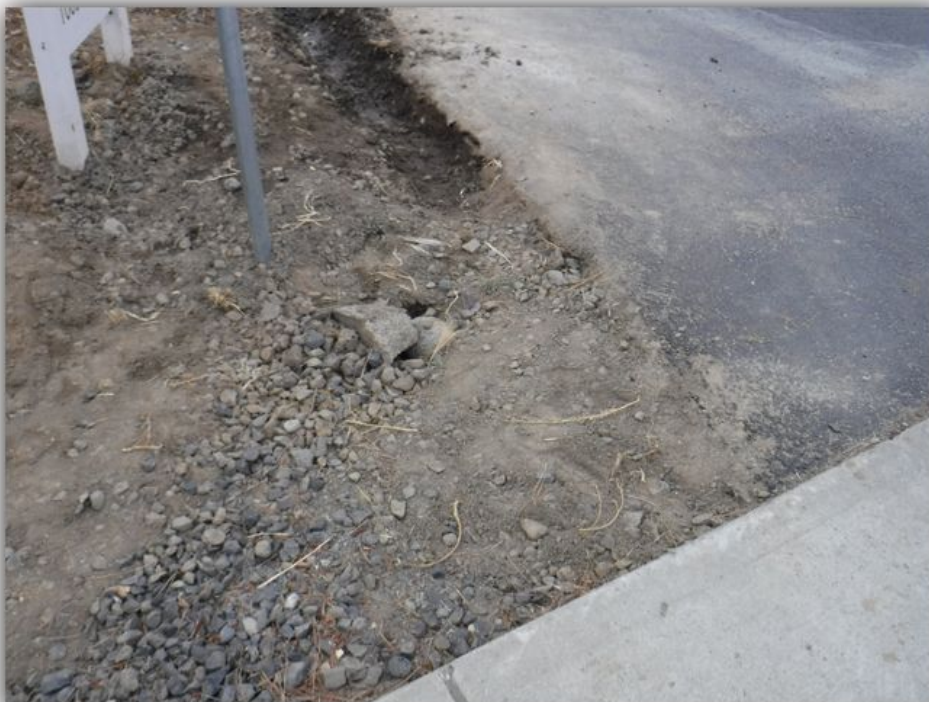
Photo Number  
**32**

Description:  
Apparent filled in culvert at  
Bolan and Upper West Bolan.

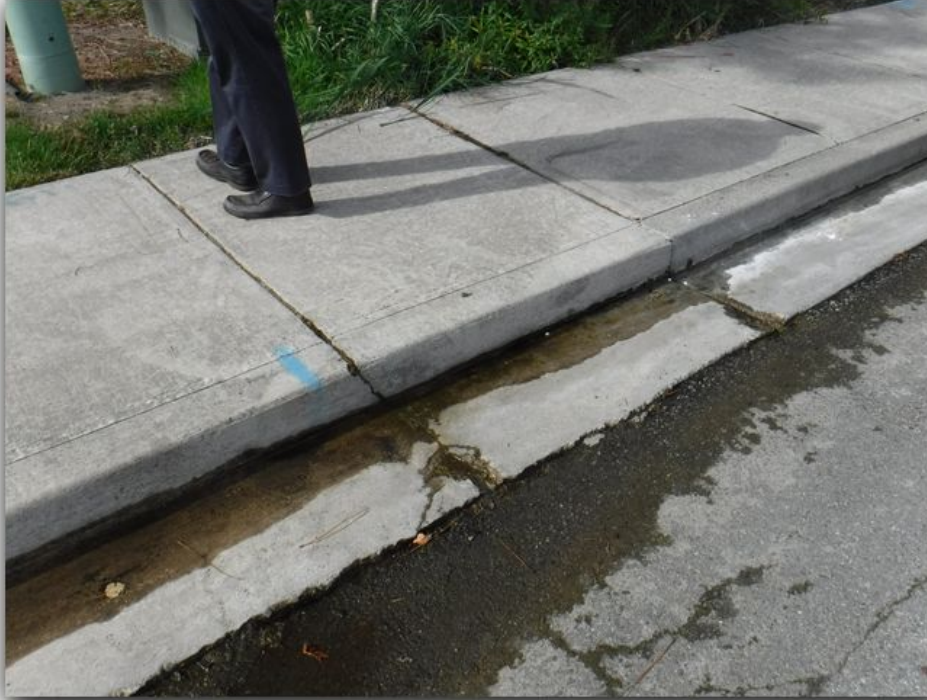
Photo Number  
**33**

Runoff from hillside flowing onto sidewalk and street along Bolan.

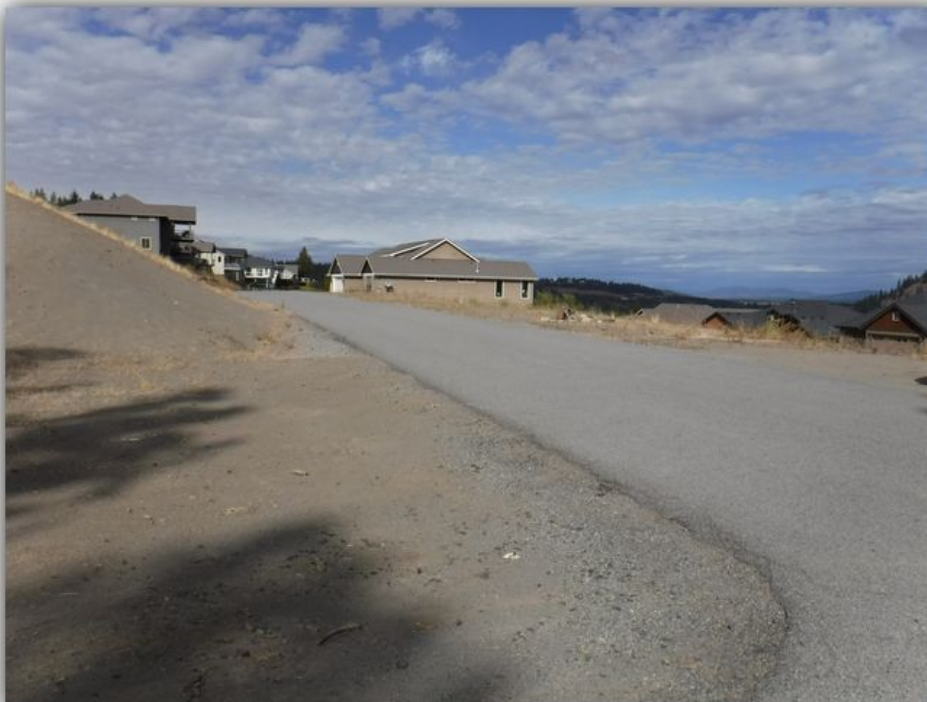
Photo Number  
**34**

Unnamed street south of Jordan not on community property.
